**Flood Control Project Maintenance
Levee Inspections**

Maintenance Issue Types Only, Levee Inspection Report By Mile - Spring 2017

Sutter Maintenance Yard Maintenance Area 0005

Waterway	Bank	Unit Miles	Inspection Start/End	Inspector
Unit No. 01 Butte Creek	Left	15.08	05/02/2017 05/02/2017	Bob Duffey

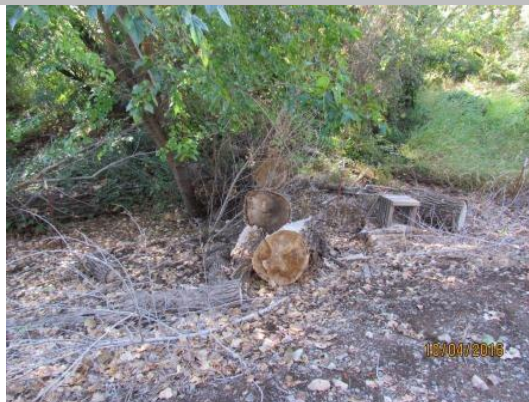
Photo 1 of 1 : SP_2017_MA0005_196_45_20170315_00022.jpg

LM Start	0.05	Rating **	M	Issue No.	45
LM End	0.05	Issue Type +	Ma	Location *	LS
Category	Earthen Levee			GPS Latitude/Longitude	
				Start	End
Item	Trim / Thin Trees			39.696790 °	39.696790 °
				-121.774154 °	-121.774154 °
DWR ID	DWR_MA0005_01_f_2016_45				
Comment Code					
T1 : Trim trees to at least five feet above ground level.					
Inspector Comment					
Remove wood logs from the waterside slope and trim trees to at least five feet above the levee slope.

View of the wood logs on the landside slope.

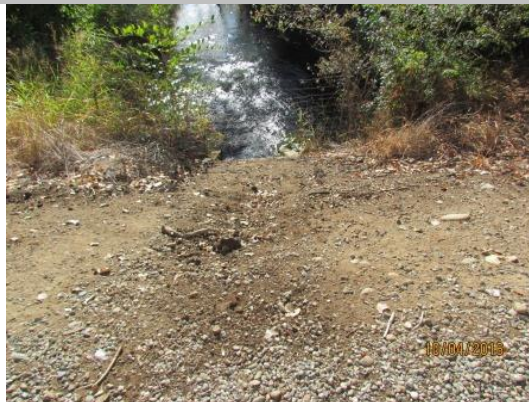
Photo 1 of 1 : SP_2017_MA0005_196_46_20170315_00023.jpg

LM Start	0.07	Rating **	M	Issue No.	46
LM End	0.07	Issue Type +	Ma	Location *	LS
Category	Earthen Levee			GPS Latitude/Longitude	
				Start	End
Item	Slope Stability			39.696611 °	39.696611 °
				-121.774349 °	-121.774349 °
DWR ID	DWR_MA0005_01_f _ 2016_46				
Comment Code					
S2 : Repair the levee slope damaged by foot traffic and prevent access where possible.					
Inspector Comment

View of the damaged slope by foot traffic.

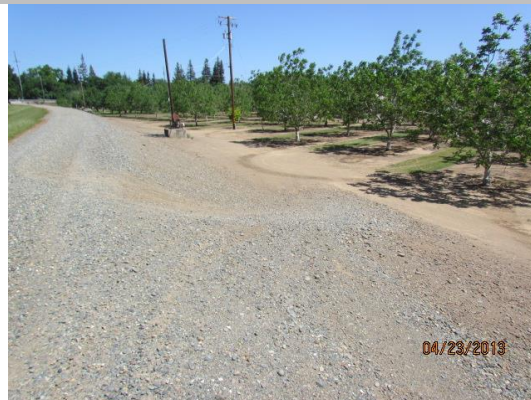
Photo 1 of 1 : SP_2017_MA0005_196_16_20170315_00006.jpg

LM Start	1.61	Rating **	M	Issue No.	16	
LM End	1.61	Issue Type +	Ma	Location *	LS	
Category	Earthen Levee			GPS Latitude/Longitude		
				Start		End
Item	Slope Stability			39.676129 °		39.676129 °
				-121.778171 °		-121.778171 °
DWR ID	DWR_MA0005_01_s_2013_16					
Comment Code						
S3 : Repair the levee slope damaged by vehicle traffic and prevent access where possible.						
Inspector Comment

View of the unauthorized vehicle ramp on the landside slope.

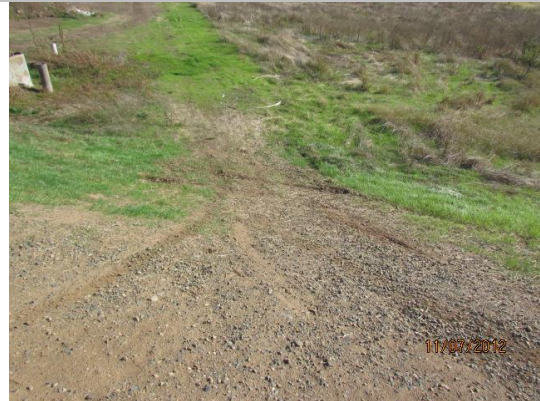
Photo 1 of 1 : SP_2017_MA0005_196_9_20170315_00004.jpg

LM Start	2.54	Rating **	M	Issue No.	9
LM End	2.54	Issue Type +	Ma	Location *	LS
Category	Earthen Levee			GPS Latitude/Longitude	
				Start	End
Item	Slope Stability			39.663876 °	39.663876 °
				-121.784014 °	-121.784014 °
DWR ID	DWR_MA0005_01_f _ 2012_9				
Comment Code					
S3 : Repair the levee slope damaged by vehicle traffic and prevent access where possible.					
Inspector Comment

View of the vehicle erosion along the landside slope.

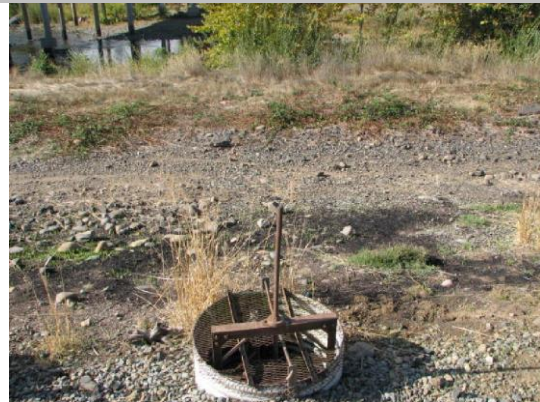
Photo 1 of 3 : UCIP_SP_2017_50843_67931.jpg

Comment Code						
Inspector Comment						
FS_ID:50843 DS_ID:1616 EP_NO: N/A Repair Type: No Action Needed Crossing Status: Found UCIP Comments: 11/15/2016 Crossing appears to be in good condition. (DWR Sutter Yard- A Freitag)5/9/2016 Crossing appears to be in good condition.8/5/2015 WS pipe end is being overgrown by trees and other vegetation. Needs to be cleared back.12/8/2014 Same as last inspection.6/11/2014 Same as last inspection.11/20/2013 Same as last inspection.5/29/2013 Same as last inspection. FIELD_STRUCT_DESC: 24-inch corrugated metal drainage pipe through the levee, 16.5 feet below the crown. Slide gate in a corrugated metal riser on the waterside (WS) slope. Flap gate on the waterside toe. Inlet on the landside (LS) toe, not found. [Additional Reference(s): DWR Levee Log, 1990. USACE Sacramento O&M Manual 516, April 1960 (Station 381+36)]. FS Date: 11/21/2016 1:34:00 PM

CMP riser and slide gate on WS shoulder.

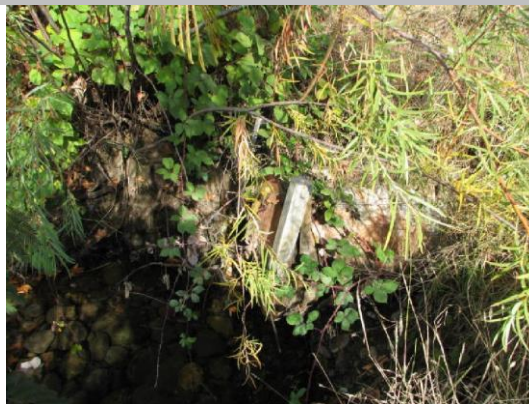
Photo 3 of 3 : UCIP_SP_2017_50843_67929.jpg

FS_ID:50843
 DS_ID:1616
 EP_NO: N/A
 Repair Type: No Action Needed
 Crossing Status: Found
 UCIP Comments: 11/15/2016 Crossing appears to be in good condition. (DWR Sutter Yard- A Freitag) 5/9/2016 Crossing appears to be in good condition. 8/5/2015 WS pipe end is being overgrown by trees and other vegetation. Needs to be cleared back. 12/8/2014 Same as last inspection. 6/11/2014 Same as last inspection. 11/20/2013 Same as last inspection. 5/29/2013 Same as last inspection.
 FIELD_STRUCT_DESC: 24-inch corrugated metal drainage pipe through the levee, 16.5 feet below the crown. Slide gate in a corrugated metal riser on the waterside (WS) slope. Flap gate on the waterside toe. Inlet on the landside (LS) toe, not found. [Additional Reference(s): DWR Levee Log, 1990. USACE Sacramento O&M Manual 516, April 1960 (Station 381+36)].
 FS Date: 11/21/2016 1:34:00 PM

Flap gate in channel at WS toe.

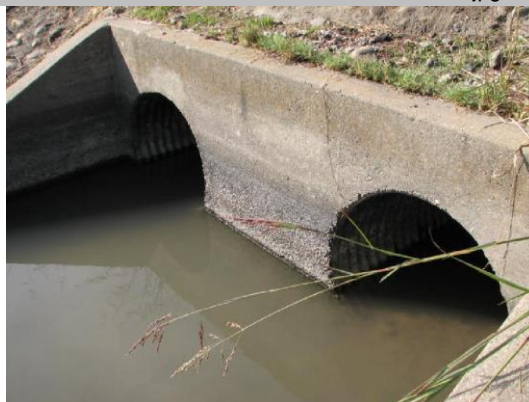
Photo 2 of 3 : UCIP_SP_2017_50847_67938.jpg

FS_ID:50847
DS_ID:1768
EP_NO: N/A
Repair Type: Non-Urgent
Crossing Status: Found
UCIP Comments: 11/15/2016 Abandoned. Needs standpipe cover.
(DWR Sutter Yard- A Freitag) 5/9/2016 Abandoned pipe. Needs a cover for standpipe. 8/5/2015 Abandoned pipes. Need covers made for tops of standpipes to prevent falls. 12/8/2014 Same as last inspection. 6/11/2014 Same as last inspection. 11/19/2013 Same as last inspection. 5/29/2013 Same as last inspection. Land owner said pipes are abandoned and no longer used. Covers should be made for top of standpipe to prevent falls. Pipes should be properly abandoned. 10/30/2012 Pipe 1/2 filled with soil at slide gate on WS. FIELD_STRUCT_DESC: *ABANDONED* 2 of 2: 36-inch corrugated metal drainage pipe through the levee, 11 feet below the crown. Slide gate in a 54-inch corrugated metal riser on the waterside (WS) slope. Concrete "U" shaped headwall on the landside (LS). [Additional Reference(s): DWR Levee Log, 1990. Sacramento O&M Manual 516, April 1960 (Station 470+00)].

Headwall at LS toe.

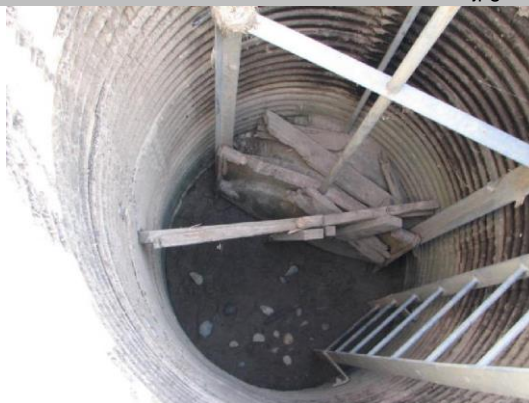
Photo 3 of 3 : UCIP_SP_2017_50847_67937.jpg

FS_ID:50847
DS_ID:1768
EP_NO: N/A
Repair Type: Non-Urgent
Crossing Status: Found
UCIP Comments: 11/15/2016 Abandoned. Needs standpipe cover.
(DWR Sutter Yard- A Freitag) 5/9/2016 Abandoned pipe. Needs a cover for standpipe. 8/5/2015 Abandoned pipes. Need covers made for tops of standpipes to prevent falls. 12/8/2014 Same as last inspection. 6/11/2014 Same as last inspection. 11/19/2013 Same as last inspection. 5/29/2013 Same as last inspection. Land owner said pipes are abandoned and no longer used. Covers should be made for top of standpipe to prevent falls. Pipes should be properly abandoned. 10/30/2012 Pipe 1/2 filled with soil at slide gate on WS.
FIELD_STRUCT_DESC: *ABANDONED* 2 of 2: 36-inch corrugated metal drainage pipe through the levee, 11 feet below the crown. Slide gate in a 54-inch corrugated metal riser on the waterside (WS) slope. Concrete "U" shaped headwall on the landside (LS). [Additional Reference(s): DWR Levee Log, 1990. Sacramento O&M Manual 516, April 1960 (Station 470+00)].

Slide gate at bottom of cmp riser.

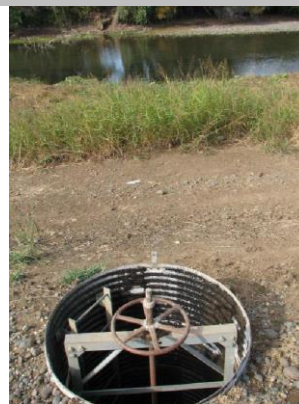
Photo 2 of 2 : UCIP_SP_2017_50848_67940.jpg

FS_ID:50848
DS_ID:1620
EP_NO: N/A
Repair Type: Non-Urgent
Crossing Status: Found
UCIP Comments: 11/15/2016 Abandoned. Needs cover for the standpipe. (DWR Sutter Yard- AFreitag)5/9/2016 Abandoned pipe. Needs a cover for the standpipe.8/5/2015 Abandoned crossing. Covers need to be made for tops of standpipes to prevent falls.12/8/2014 Same as last inspection.6/11/2014 Same as last inspection.11/19/2013 Same as last inspection.5/29/2013 Same as last inspection. Land owner said pipes are abandoned and no longer used. Covers should be made for top of standpipe to prevent falls. Pipes should be properly abandoned.10/30/2012 Pipe 1/2 filled with soil at slide gate end.
FIELD_STRUCT_DESC: *ABANDONED* 1 of 2: 36-inch drainage pipe through the levee, 11 feet below the crown. Slide gate in a 54-inch corrugated metal riser on the waterside (WS) slope. Concrete "U" headwall on the landside (LS). [Additional Reference(s): DWR Levee Log, 1990. Sacramento O&M Manual 516, April 1960 (Station 470+00)].

54-inch CMP riser and slide gate on WS shoulder.

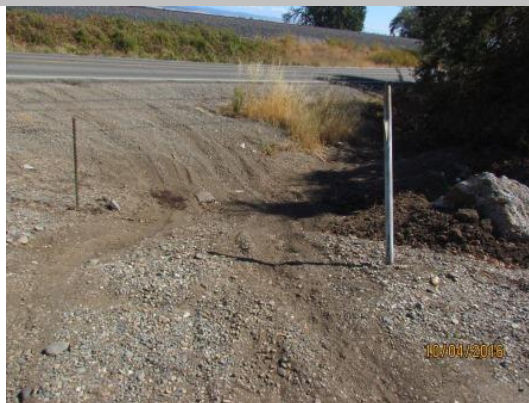
Photo 1 of 1 : SP_2017_MA0005_196_58_20170315_00032.jpg

LM Start	7.14	Rating **	M	Issue No.	58
LM End	7.14	Issue Type +	Ma	Location *	LS
Category	Earthen Levee			GPS Latitude/Longitude	
				Start	End
Item	Slope Stability			39.603648 °	39.603648 °
				-121.784114 °	-121.784114 °
DWR ID	DWR_MA0005_01_f_2016_58				
Comment Code					
S3 : Repair the levee slope damaged by vehicle traffic and prevent access where possible.					
Inspector Comment

View of the damaged landside slope by vehicle traffic.

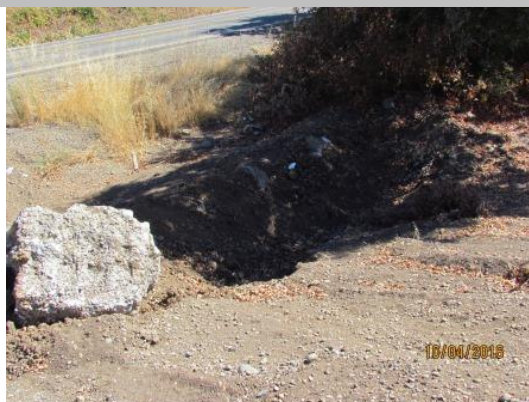
Photo 1 of 1 : SP_2017_MA0005_196_59_20170315_00033.jpg

LM Start	7.14	Rating **	M	Issue No.	59
LM End	7.14	Issue Type +	Ma	Location *	LS
Category	Earthen Levee			GPS Latitude/Longitude	
				Start	End
Item	Slope Stability			39.603611 °	39.603611 °
				-121.784132 °	-121.784132 °
DWR ID	DWR_MA0005_01_f_2016_59				
Comment Code					
S1 : Repair slope instability.					
Inspector Comment

View of the rocks and cut in the landside levee toe.

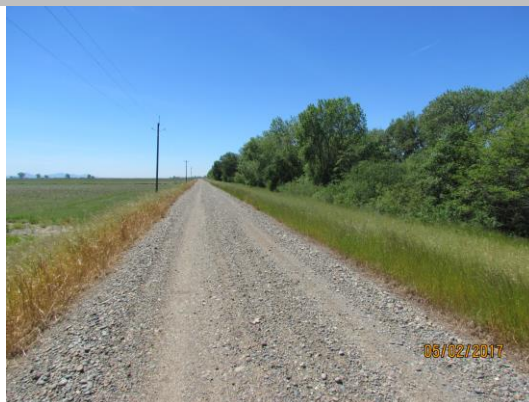
Photo 1 of 1 : SP_2017_MA0005_196_66_20170508_00085.jpg

LM Start	7.38	Rating **	A	Issue No.	66
LM End	7.38	Issue Type +	Ma	Location *	LS
Category	Earthen Levee			GPS Latitude/Longitude	
				Start	End
Item	Vegetation			39.600403 °	39.600403 °
				-121.785862 °	-121.785862 °
DWR ID	DWR_MA0005_01_s_2017_66				
Comment Code					
V1 : Control annual grass and weeds on the levee slopes and easements.					
Inspector Comment

View of native grasses on both slopes.

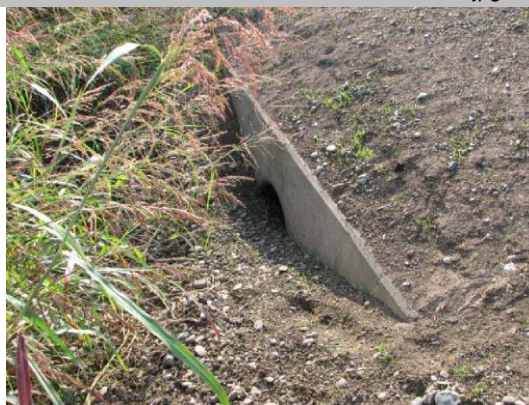
Photo 2 of 2 : UCIP_SP_2017_50864_67969.jpg

FS_ID:50864
DS_ID:1628
EP_NO: N/A
Repair Type: Non-Urgent
Crossing Status: Found
UCIP Comments: 11/15/2016 Appears abandoned and should be done so properly. (DWR Sutter Yard- AFreitag)5/11/2016 Possibly an abandoned crossing. LS inlet was over 50% buried and nothing was found on the WS.8/4/2015 LS pipe end filled about 50% with soil and WS pipe end is buried.12/8/2014 Same as last inspection.6/11/2014 Same as last inspection.11/19/2013 Same as last inspection.5/29/2013 Same as last inspection.10/30/2012 Pipe filled with soil and outlet/appurtenances are buried.
FIELD_STRUCT_DESC: *ABANDONED* 24-inch corrugated metal drainage pipe through the levee, 8.5 feet below the crown. Flap gate on the waterside (WS). Concrete "U" shaped headwall on the landside (LS) toe. [Additional Reference(s): DWR Levee Log, 1990. Sacramento O&M Manual 515, April 1955 (Station 576+72), USACE As-built Drawings 50-4-2637, Exhibit B, Sheet 2, April 1950 (station 576+72.4)].

Headwall at LS toe.

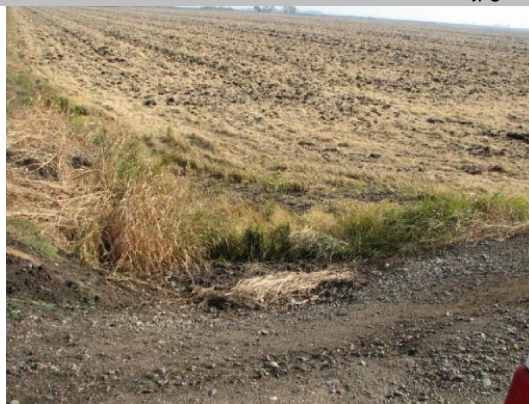
Photo 2 of 3 : UCIP_SP_2017_50865_67972.jpg

FS_ID:50865
DS_ID:1629
EP_NO: N/A
Repair Type: Non-Urgent
Crossing Status: Found
UCIP Comments: 11/15/2016 LS inlet was unburied and entire pipe is about 25% full of soil. WS flapgate was shut and partially buried. (DWR Sutter Yard- A Freitag) 5/11/2016 WS flap gate was about 50% buried and LS was 100% buried. Appears to be an abandoned crossing. 8/4/2015 WS flap gate is partially buried by soil and being overgrown with vegetation. LS pipe end was underwater and suspected to still be completely buried with soil. 12/8/2014 Same as last inspection. 6/11/2014 Same as last inspection. 11/19/2013 Same as last inspection. 5/29/2013 Same as last inspection. 10/30/2012 Pipe filled with soil.
FIELD_STRUCT_DESC: 24-inch corrugated metal drainage pipe through the levee, 9.3 feet below the crown. Flap gate on the waterside (WS). Concrete headwall at the landside (LS) and the WS toes.
[Additional Reference(s): DWR Levee Log, 1990. Sacramento O&M 515, April 1955 (Station 609+79). USACE As-Built Drawing 50-4-2637, Exhibit B, Sheet 3, April 1950 (Station 609+78.5)].

Buried inlet at LS toe.

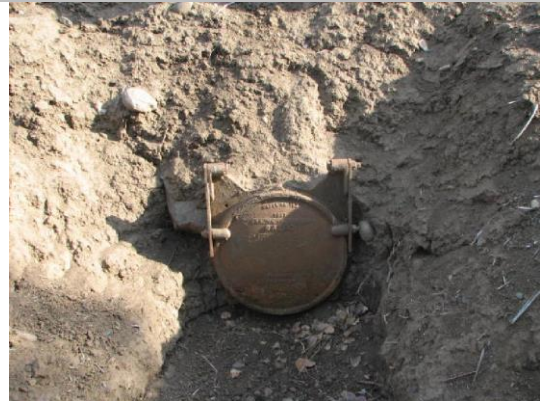
Photo 3 of 3 : UCIP_SP_2017_50865_67971.jpg

FS_ID:50865
DS_ID:1629
EP_NO: N/A
Repair Type: Non-Urgent
Crossing Status: Found
UCIP Comments: 11/15/2016 LS inlet was unburied and entire pipe is about 25% full of soil. WS flapgate was shut and partially buried. (DWR Sutter Yard- A Freitag) 5/11/2016 WS flap gate was about 50% buried and LS was 100% buried. Appears to be an abandoned crossing. 8/4/2015 WS flap gate is partially buried by soil and being overgrown with vegetation. LS pipe end was underwater and suspected to still be completely buried with soil. 12/8/2014 Same as last inspection. 6/11/2014 Same as last inspection. 11/19/2013 Same as last inspection. 5/29/2013 Same as last inspection. 10/30/2012 Pipe filled with soil.
FIELD_STRUCT_DESC: 24-inch corrugated metal drainage pipe through the levee, 9.3 feet below the crown. Flap gate on the waterside (WS). Concrete headwall at the landside (LS) and the WS toes.
[Additional Reference(s): DWR Levee Log, 1990. Sacramento O&M 515, April 1955 (Station 609+79). USACE As-Built Drawing 50-4-2637, Exhibit B, Sheet 3, April 1950 (Station 609+78.5)].

Flap gate at WS toe.

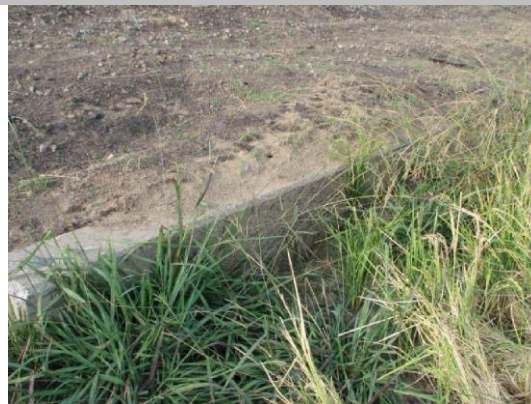
Photo 2 of 2 : UCIP_SP_2017_50875_67990.jpg

FS_ID:50875
DS_ID:1635
EP_NO: N/A
Repair Type: Non-Urgent
Crossing Status: Found
UCIP Comments: 11/15/2016 Abandoned. (DWR Sutter Yard-AFreitag)5/11/2016 Abandoned crossing.8/4/2015 Abandoned pipe. Casey Wilder has started the steps to have the pipe properly abandoned and removed from the levee.12/8/2014 Same as last inspection.6/11/2014 Same as last inspection.11/19/2013 Same as last inspection.5/29/2013 Same as last inspection.10/30/2012 Pipe buried on both sides of levee.
FIELD_STRUCT_DESC: *ABANDONED* 30-inch corrugated metal drainage pipe through the levee, 12.2 feet below the crown. Flap gate on the waterside (WS) end. [Additional Reference(s): DWR Levee Log, 1990. USACE Sacramento O&M Manual 515, April 1955 (Station 748+53). USACE As-built Drawing 50-4-2637, Exhibit B, Sheet 4, April 1950 (Station 748+53)].
FS Date: 11/21/2016 2:26:09 PM

Concrete headwall at LS toe.

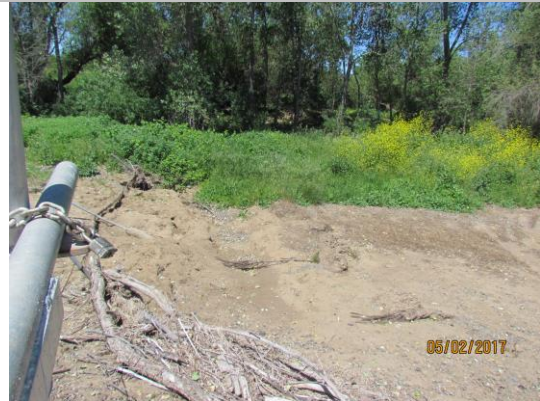
Photo 1 of 1 : SP_2017_MA0005_196_67_20170508_00086.jpg

LM Start	10.87	Rating **	M	Issue No.	67
LM End	10.87	Issue Type +	Ma	Location *	WS
Category	Earthen Levee			GPS Latitude/Longitude	
				Start	End
Item	Slope Stability			39.562177 °	39.562177 °
				-121.826072 °	-121.826072 °
DWR ID	DWR_MA0005_01_s_2017_67				
Comment Code					
S1 : Repair slope instability.					
Inspector Comment					
Repair the erosion along the water side slope.

View of erosion along the waterside slope.

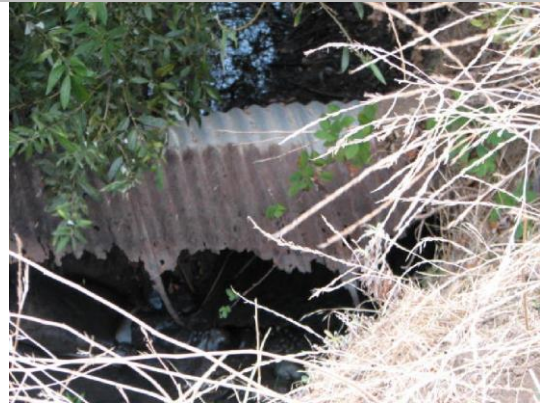
Photo 3 of 3 : UCIP_SP_2017_50886_68015.jpg

Heavily corroded CMP pipe at WS toe.

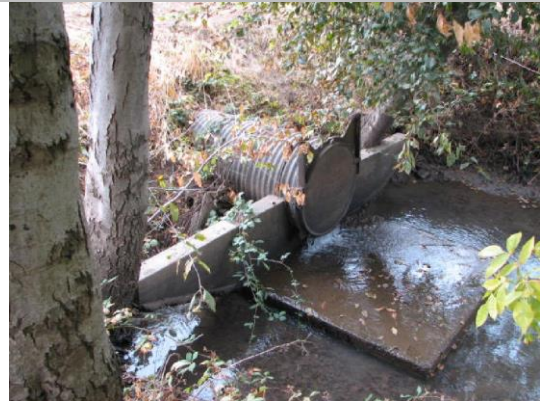
Photo 3 of 3 : UCIP_SP_2017_50891_68031.jpg

Wingwalls of headwall not supported by soil.

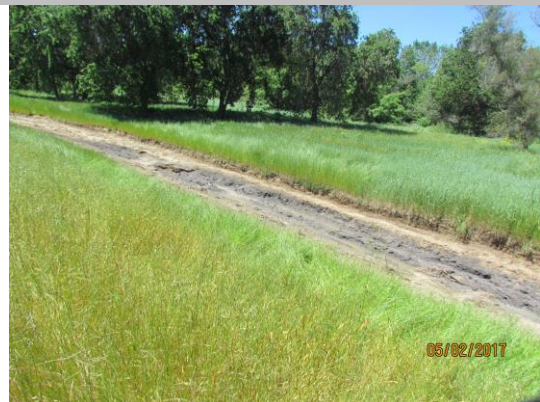
Photo 1 of 1 : SP_2017_MA0005_196_68_20170508_00088.jpg

View of the erosion along the waterside toe.

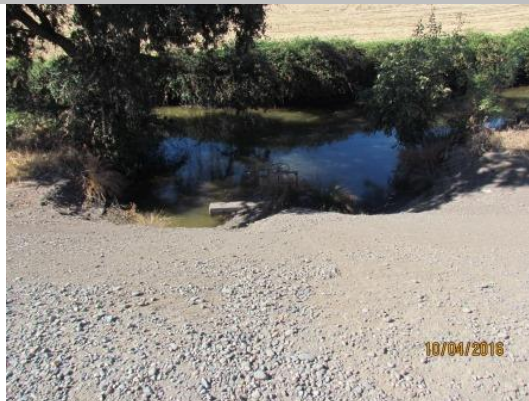
Photo 1 of 1 : SP_2017_MA0005_197_49_20170315_00024.jpg

View of the landside toe erosion.

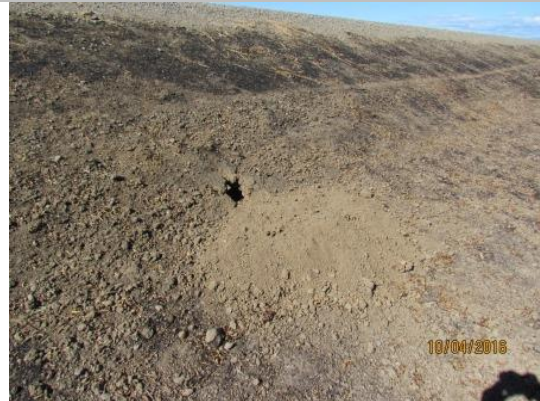
Photo 1 of 1 : SP_2017_MA0005_197_50_20170315_00025.jpg

View of the rodent holes along the landside slope.

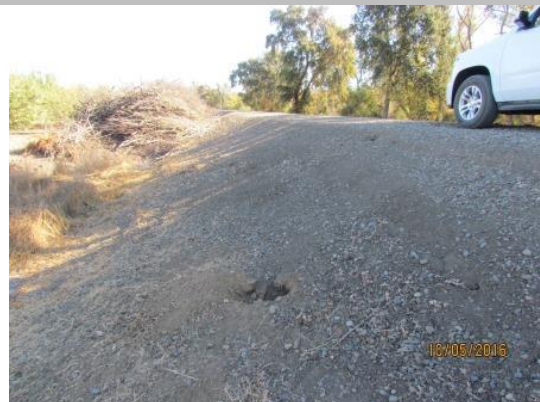
Photo 1 of 2 : SP_2017_MA0005_197_53_20170315_00028.jpg

View of the rodent holes along the landside slope.

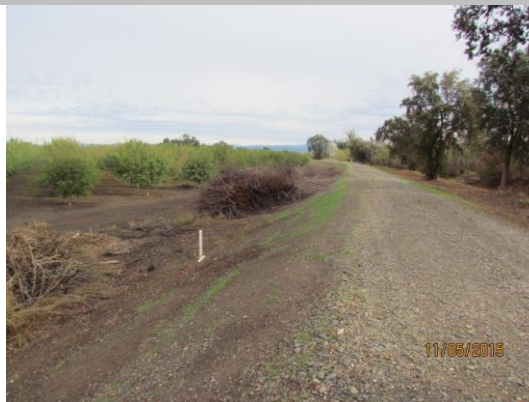
Photo 1 of 1 : SP_2017_MA0005_197_35_20170315_00012.jpg

View of the prunings along the landside slope.

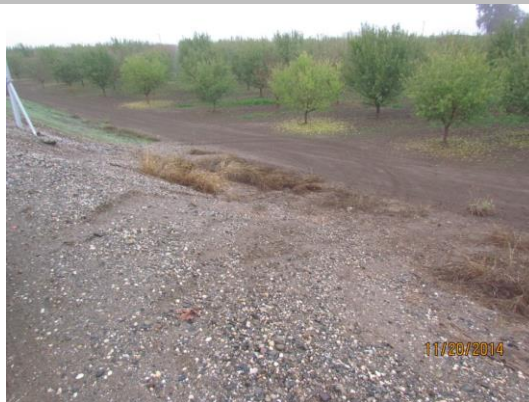
Photo 1 of 2 : SP_2017_MA0005_197_13_20170315_00005.jpg

View of the vehicle erosion along the landside slope.

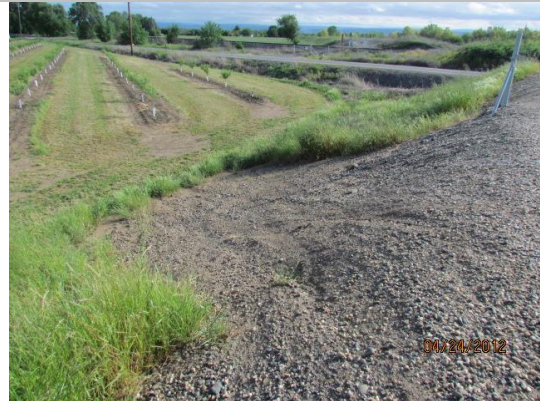
Photo 2 of 2 : SP_2017_MA0005_197_13_20170315_00006.jpg

View of the vehicle erosion along the slope.

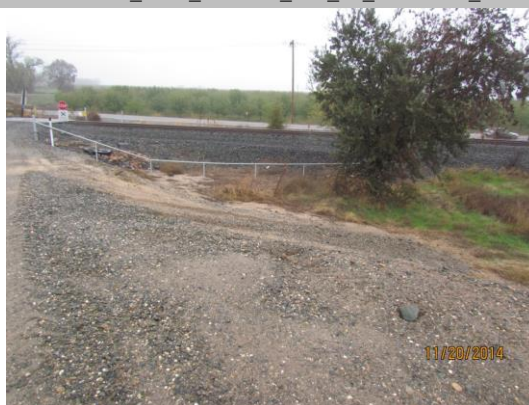
Photo 1 of 1 : SP_2017_MA0005_197_40_20170315_00016.jpg

View of the vehicle slope instability along the landside slope.

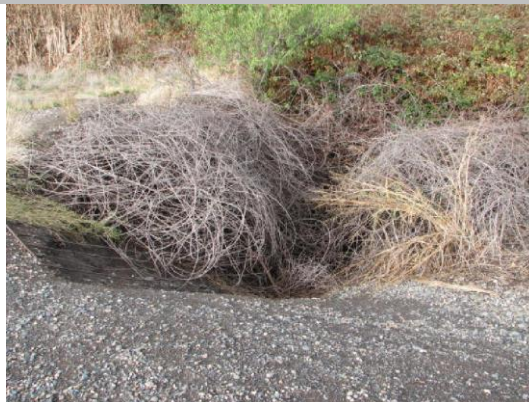
Photo 2 of 3 : UCIP_SP_2017_50940_68404.jpg

Brambles and soil over pipe at inlet.

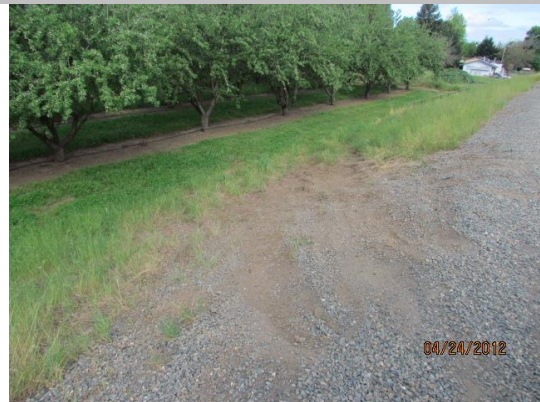
Photo 1 of 1 : SP_2017_MA0005_197_18_20170315_00007.jpg

View of the vehicle erosion along the slope of the levee.

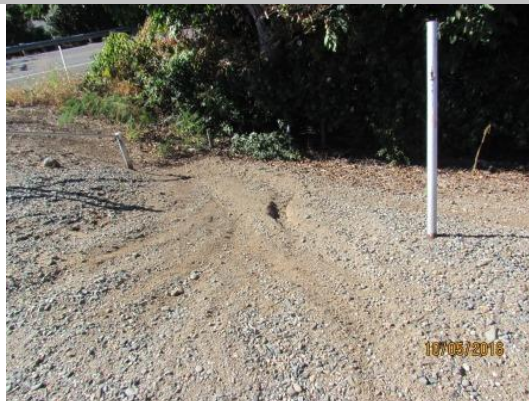
Photo 1 of 1 : SP_2017_MA0005_197_58_20170315_00034.jpg

View of the damaged landside slope.

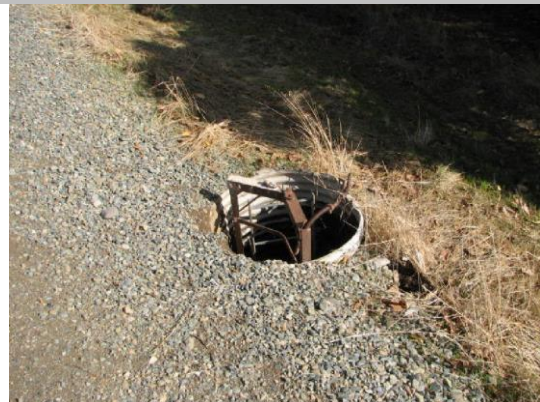
Photo 1 of 3 : UCIP_SP_2017_50950_68465.jpg

Broken slide gate in CM riser on WS slope.

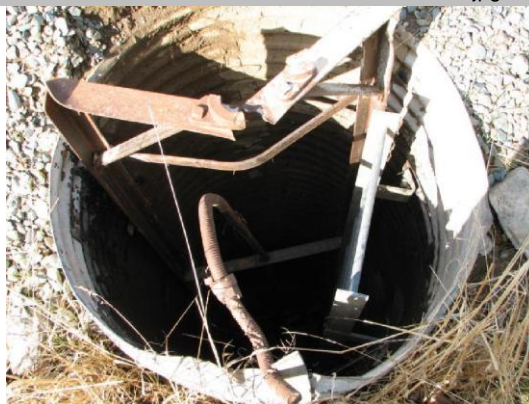
Photo 3 of 3 : UCIP_SP_2017_50950_68463.jpg

Broken slide gate in CM riser on WS slope.

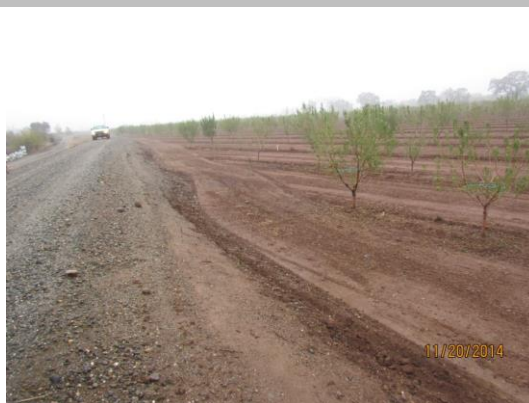
Photo 1 of 1 : SP_2017_MA0005_197_43_20170315_00019.jpg

View of the tilling into the landside slope.

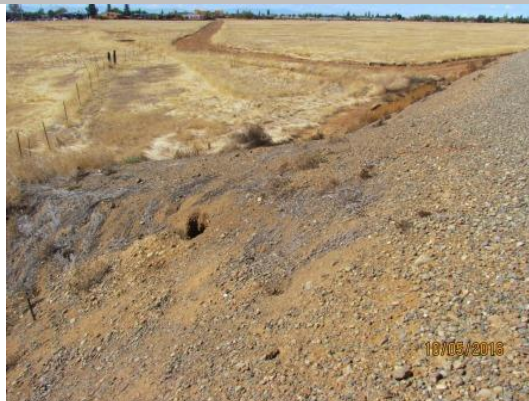
Photo 1 of 1 : SP_2017_MA0005_197_39_20170315_00015.jpg

View of the rodent holes along the landside slope.
